## COMPLETION REPORT FOR PHASE 1 INTERIM ACTION AT THE FORMER SATRALLOY SITE

Mingo Junction, Ohio

**Prepared By:** Golder Associates Inc.  
18300 NE Union Hill Road, Suite 200  
Redmond, WA 98052 USA

December 14, 2017

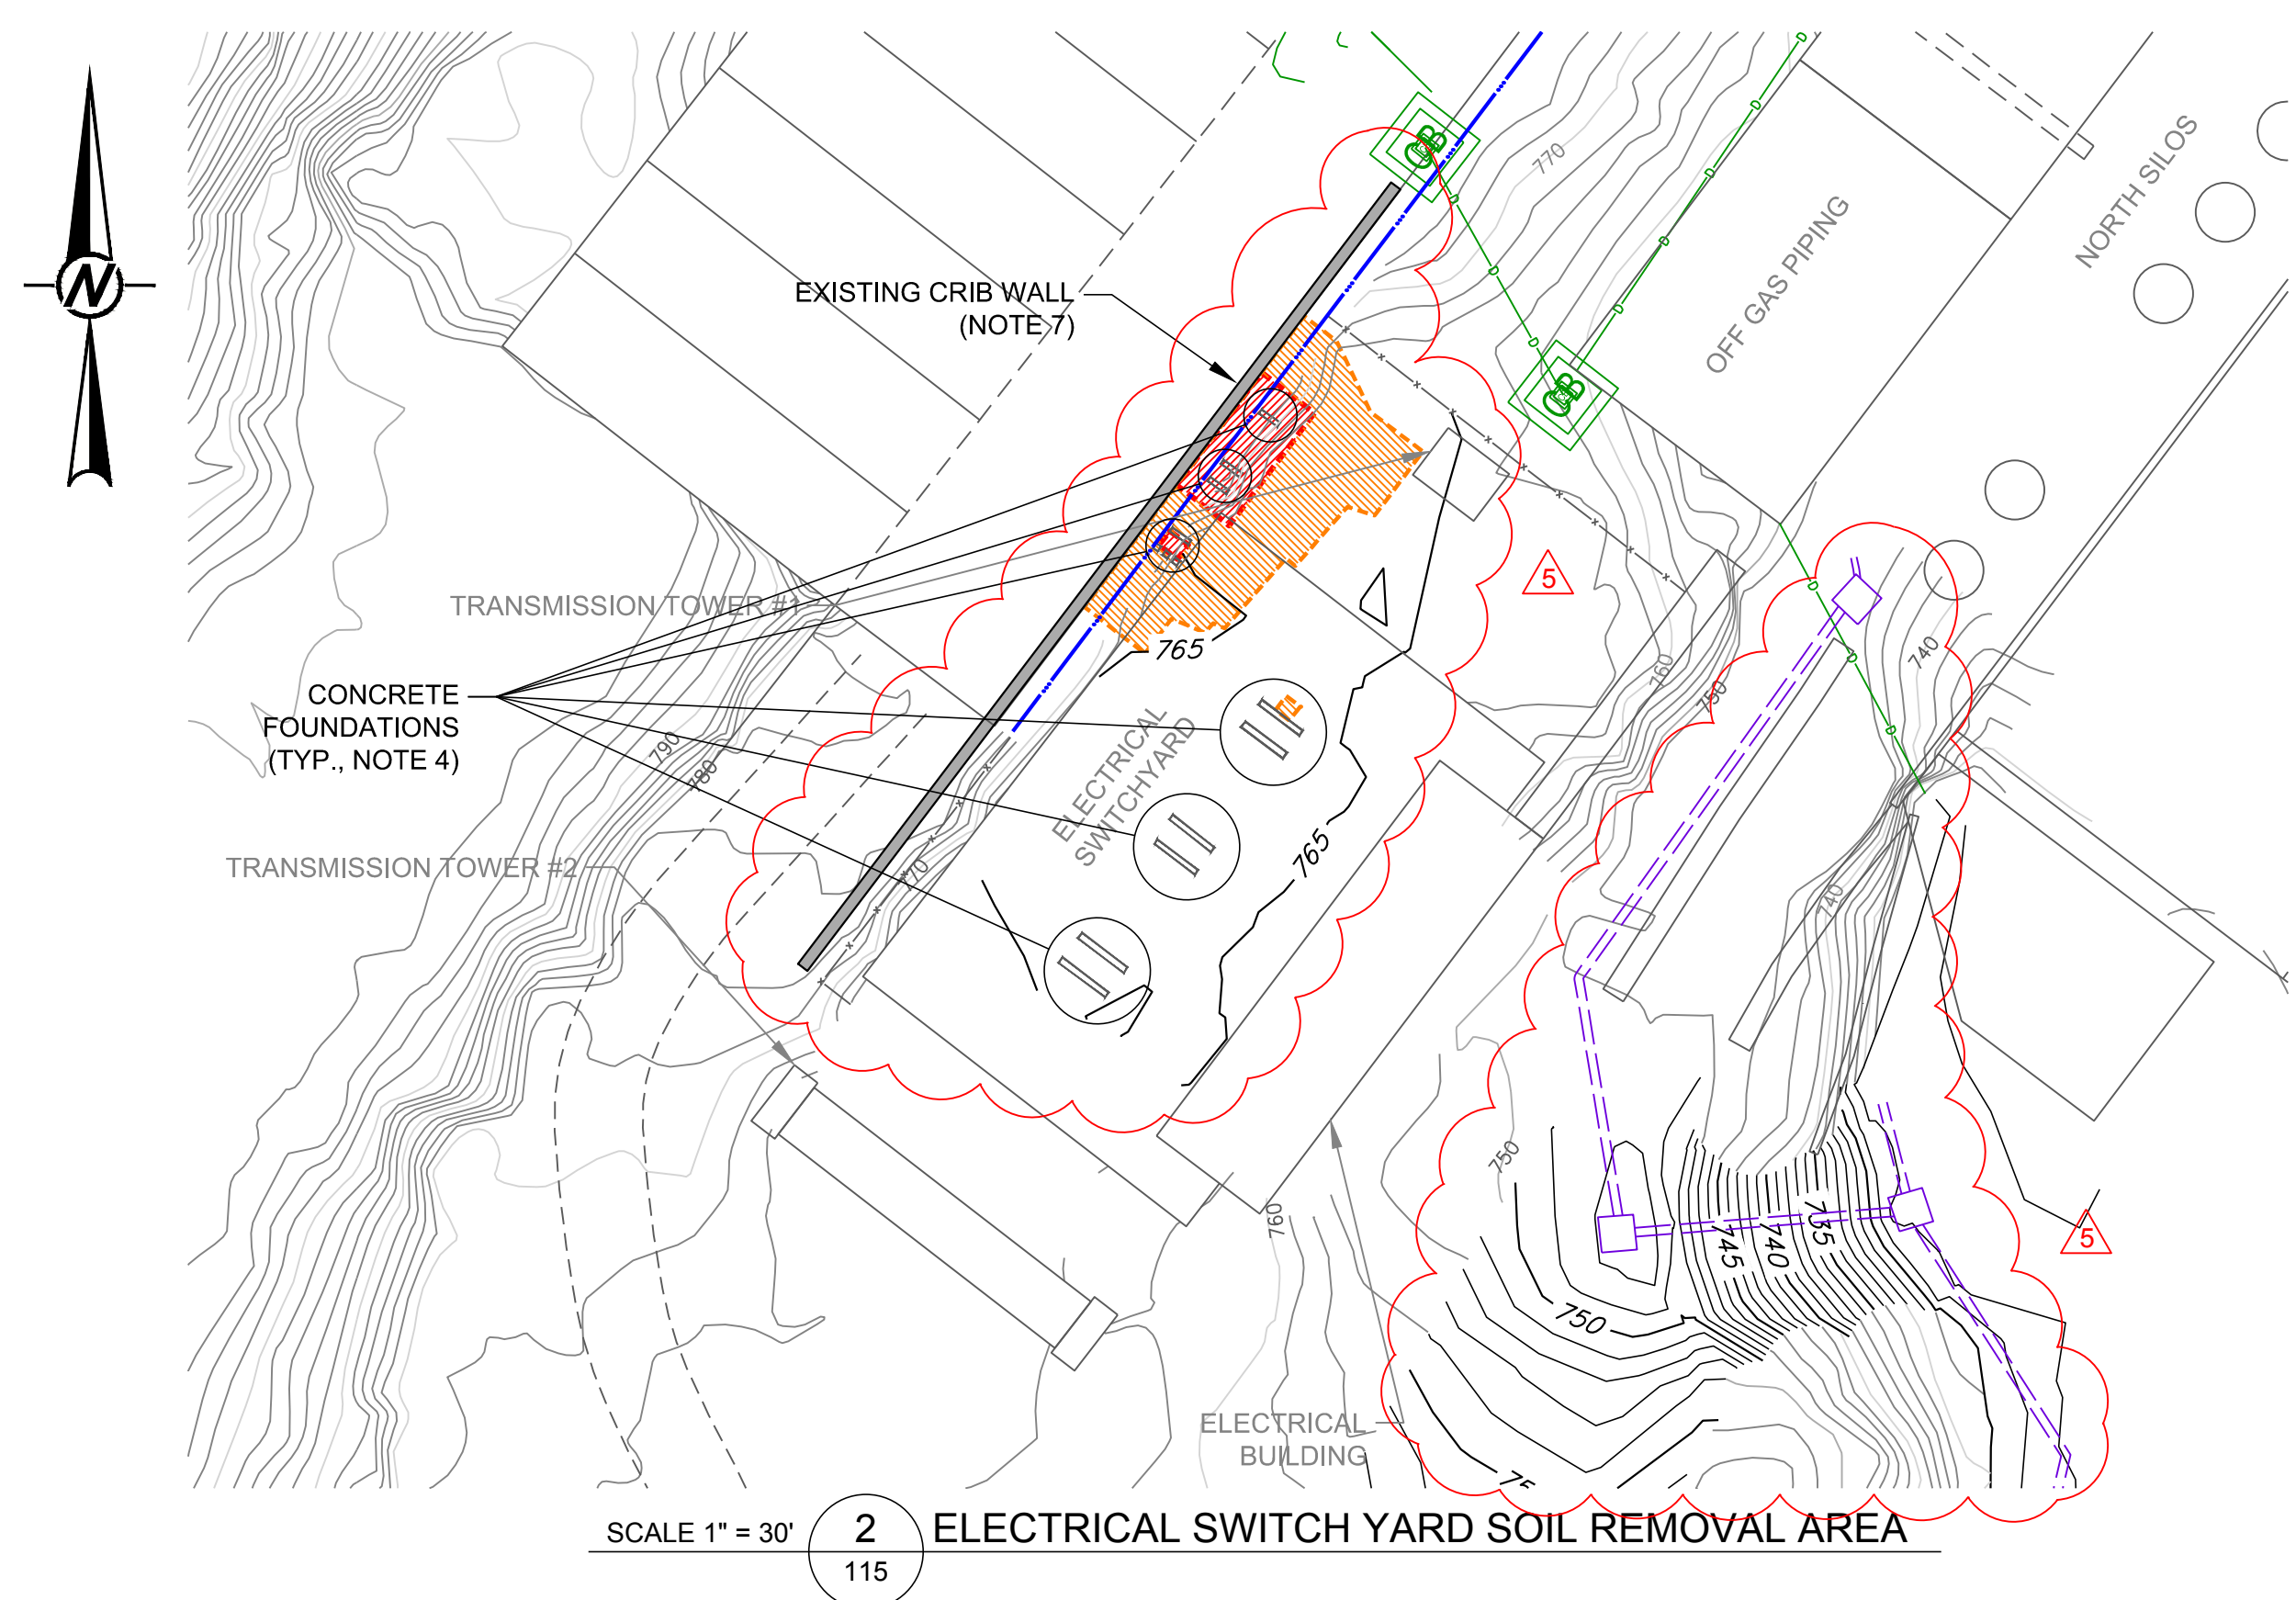
SCALE 1" = 30'  
2  
115  
ELECTRICAL SWITCH YARD SOIL REMOVAL AREA

Concrete sampling conducted in September 2014 and soil sampling done in June and August 2015 indicated that PCB impacted soil and concrete foundations were present at the northwestern end of the Electrical Switchyard. The location of the PCB cleanup was confined to a relatively small area (approximately 1,400 square feet) of the switchyard, where electrical transformers were formerly located. These transformers were removed by the (USEPA) as part of a Site-wide PCB removal action in the 1990s. The objective of the self-implementing cleanup was to remove PCB-impacted soil and concrete with total PCB concentrations exceeding 2 mg/kg for soil.

The soil sampling conducted in the switchyard in 2015 indicated a limited area exceeded the US EPA cleanup level of 50 mg/kg (ppm) surrounded by a larger area where PCB concentrations were less than the 50 mg/kg cleanup level. Concrete transformer foundations in the switchyard were also found to contain surficial PCB concentrations <50 mg/kg. PCB-impacted soil was categorized into two groups: one with PCB concentrations >50 mg/kg were designated as Level A for disposal at a Toxic Substances Control Act (TSCA) facility permitted to receive PCB waste; and another group with PCB concentrations below 50 mg/kg were designated as Level B for disposal as non-hazardous waste.

Soils and concrete impacted by polychlorinated biphenyls (PCBs) were found in areas of the decommissioned Electrical Switchyard, removal of the impacted materials was beneficial to achieving the requirements of the COPI. Removal and off-site disposal of PCB-impacted material was added to the IA Workplan under Amendment 4. The work was conducted pursuant to the *Workplan & Notification for Self-Implementing PCB Cleanup – Former Satralloy Site* (Golder 2016), which was approved by United States Environmental Protection Agency (USEPA) on May 26, 2016. The PCB cleanup activities are summarized below; a more detailed description of the activities, and results thereof, are presented in a separate report submitted to USEPA and OEPA titled *Cleanup Completion Summary Report for Self-Implementing PCB Cleanup Former Satralloy Site* (Golder 2017).

After excavation was complete and verification samples indicated that the cleanup criteria had been achieved, the cleanup excavation was backfilled with soil from the on-Site Borrow Area and compacted to a firm and unyielding condition.
